SERVICE BULLETIN

787930-B2 Product: S1 Pro

Subject: No power and preventative rework

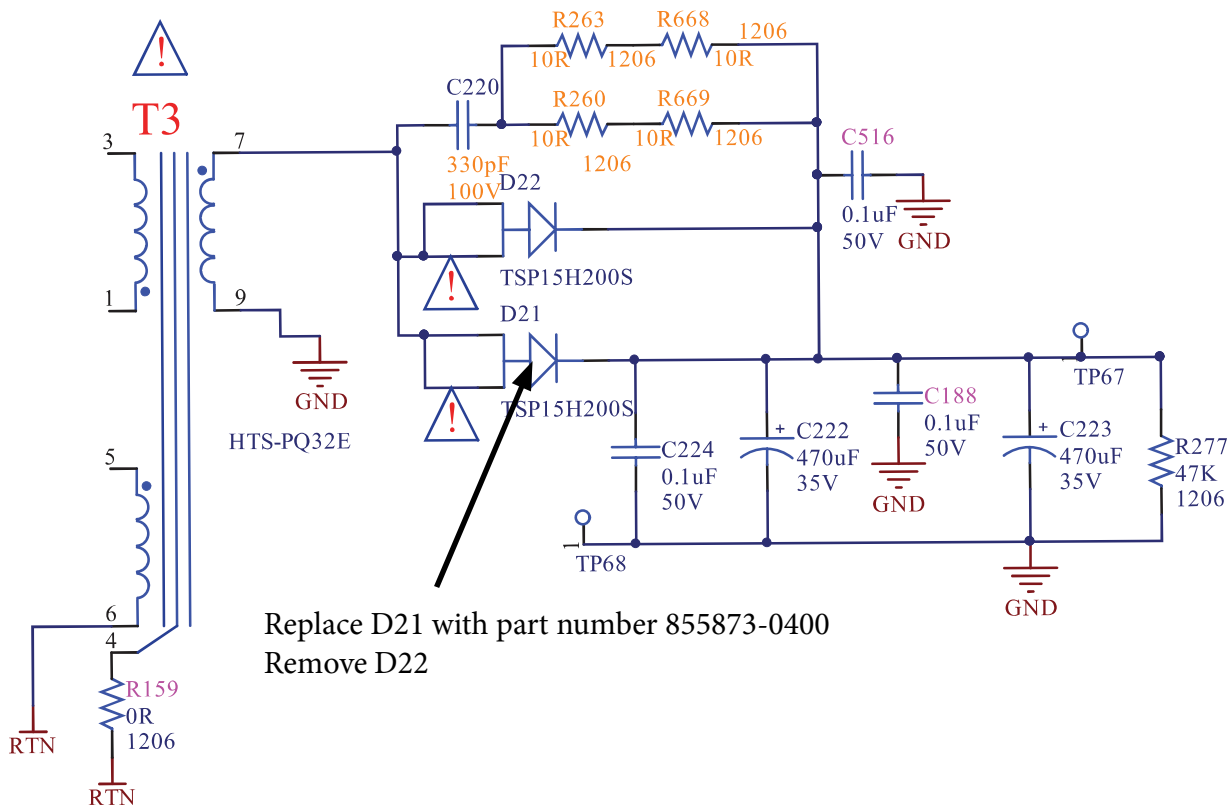
Symptom: A no power symptom can occur with D21 and D22 becoming shorted causing damage to other areas of the power supply. This preventative rework should be done regardless of symptom.

Reason: Improved power rating for D21.

Solution: Replace D21 with Bose part number 855873-0400 and remove D22 on the SMPS section of the Main PCB.
