# SERVICE BULLETIN

**Bulletin Part Number:** 344871-B1

**Product:** FreeSpace<sup>®</sup> Integrated Zone Amplifiers, IZA-250 and IZA-190

**Subject:** No power / dead unit due to unseated connector.

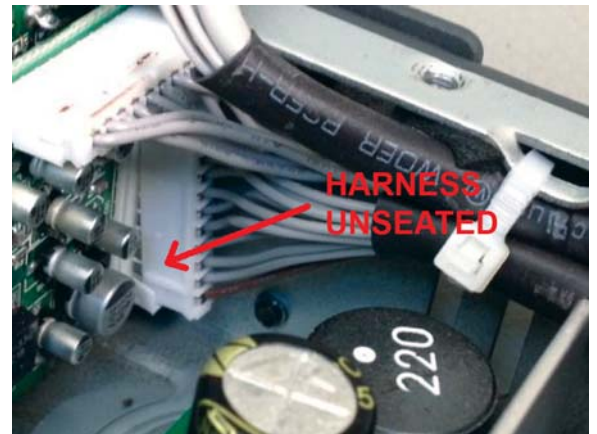
**Symptom:** Dead unit / no power up.

**Reason:** The wiring harness that connects from J4A on the DSP PCB to J4B on the SMPS/Amp PCB may have become unseated at connector J4A due to vibration during shipment from the factory. Refer to the photo at right.
