# SERVICE BULLETIN

**Bulletin Part Number:** 294963-B1

**Product:** Bose<sup>®</sup> FreeSpace<sup>®</sup> 4400 Business Music System

**Subject:** 34 Pin Power Supply/Amplifier Module to DSP PCB Ribbon Cable becomes unseated.

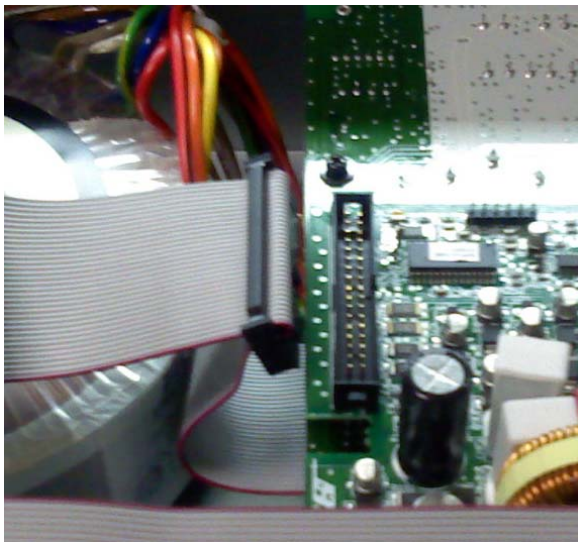
**Figure 1. Cable Unseated**

**Symptom:** Front panel amplifier channel(s) failure LED's lit or dead unit.

**Reason:** Due to tension at the bend of the 34 Pin ribbon cable it can become unseated at either the upper or lower amplifier PCB, or both. Refer to Figure 1 below.
