# SERVICE BULLETIN

Bulletin Part Number: 296133-B3

**Product:** L1® Model II and L1® Model 1S Systems

**Subject:** Wiring harness heat shrink sleeve damaged through chafing. Wiring harnesses slipping off of retaining posts due to not being glued in place.

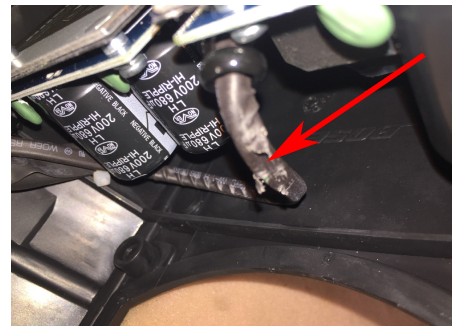
No Glue

**Reason:** Vendor process eliminated glue between above DOM range dates. Result is that the cable tie that holds the harness to the plastic pole can slip off the post.

**Solution:** Remove the leg assembly. Refer to service manual for disassembly instructions. Inspect the harness cable for any defective or loose cable ties. Replace any defective cable ties and apply RTV glue to secure the tie wrap to the post. Use RTV glue to secure the harness to the case beneath SMPS as shown in Figure 1.
