## **Bose® ControlSpace™** **V1.2 Release Notes**

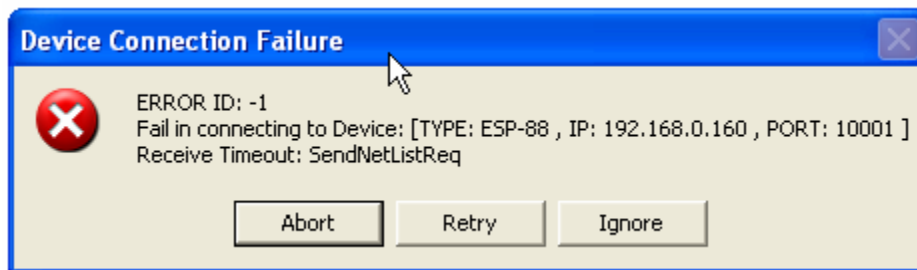
**3. Designs with Timers/Presets in CSD v1.001:**

Some designs created in version 1.001 using timers or presets may cause an upload error. A timeout message is displayed:

The power light may turn red and the ESP will require a reboot. Versions 1.1 and later, do not create files with this error.

**Workaround:** Open the file in v1.001 or the version of CSD in which it was created; delete the timers or preset and save the file. Open the file in the latest version of CSD and recreate the timers or presets.

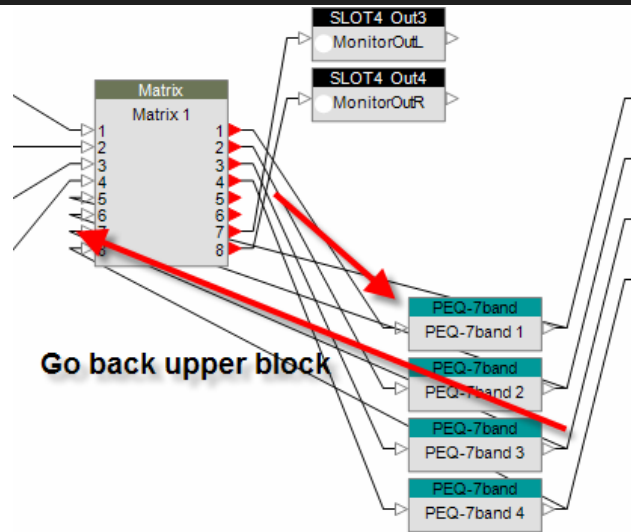
**5. Some designs created in 1.101 will not upload due to the signal processing block order:**

In some cases, designs created in v1.101 cause an upload error based on their complex signal flow. Often adding a matrix mixer or compressor solves the problem.

In the example above, PEQs are routed back into an upper block. This requires more time to allocate DSP resources and can cause timeout upload errors. Other complex signal flow can cause issues also.
