Figure correction in service manuals

The unbalanced connection diagram in the Test Procedures section of the Panaray (502) service manual, P/N 170310, and in the 402/802 II service manual, P/N 174785, is incorrect. **Figure 19 on page 33** of the 502 service manual and **Figure 24 on page 23** in the 402/802 II service manual should be changed as follows (only a partial figure is shown):

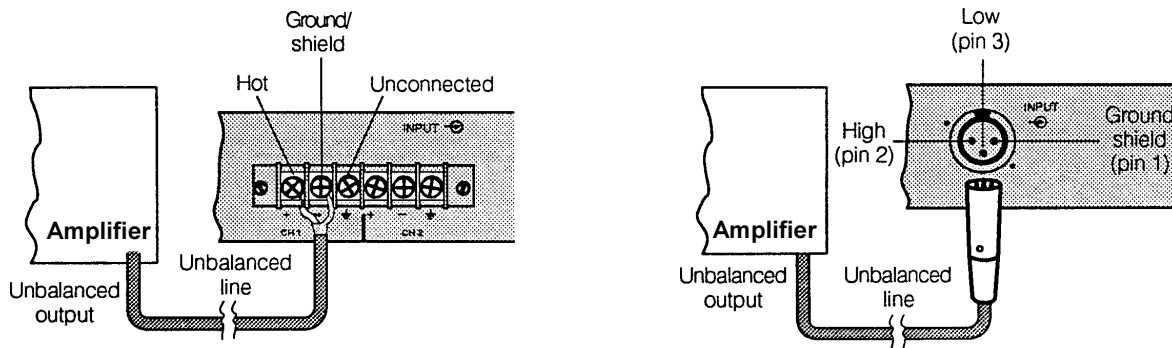
FROM:

The input device was incorrectly identified as an amplifier. It should be a signal generator or audio oscillator.
