SERVICE BULLETIN

Bulletin Number: 731419-B1

Product: F1 Model 812 Loudspeaker

Subject: Potential array latching issue due to foam compression issues.

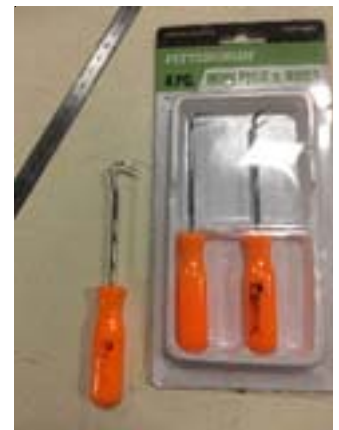
- Flashlight
- 4 piece Mini pick & hook set, or similar - <http://www.harborfreight.com/4-piece-pick-and-hook-set-66836.html> (see photo at right).
- Small Flexible metal ruler or similar.
- Black touch up paint and/or marker in case of minor damage to paint on grilles.

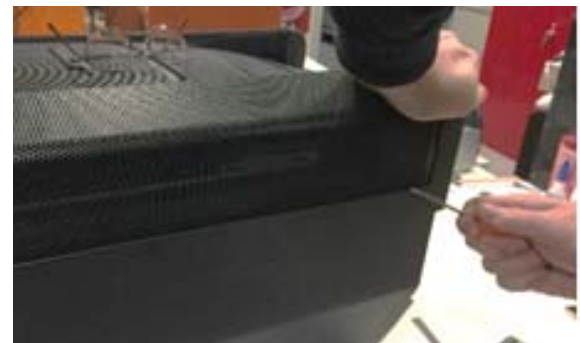
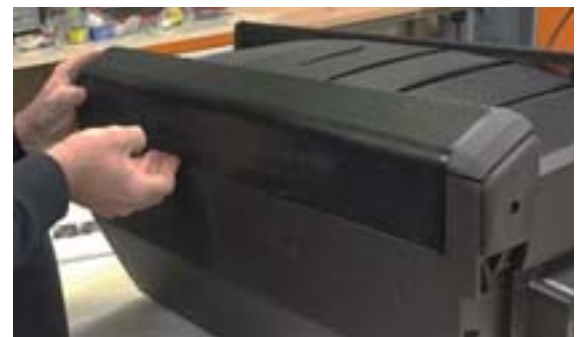
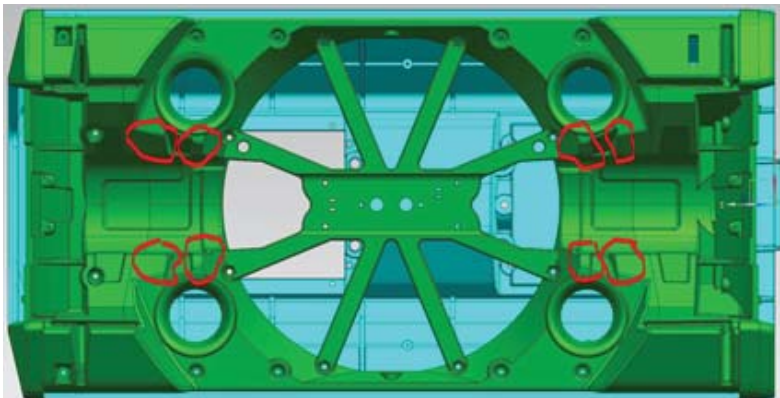
1. Fully unpack unit.
2. Place unit on its back on a soft cushion on a flat surface to prevent damage during rework.
3. Adjust the array to the straight configuration.
4. Remove the side grilles. Using a flat plastic tool or the hook tool, move the grille sides away from the loudspeaker enclosure until the retaining tabs are clear of the enclosure. There are four retaining tabs per grille. Take care to not damage the loudspeaker enclosure or the side grille. Once the retaining tabs are clear, pull the side grille straight off from the front of the enclosure.
5. You will be removing the foam as shown below. The foam is located at two locations at the top of each port, for a total of eight.

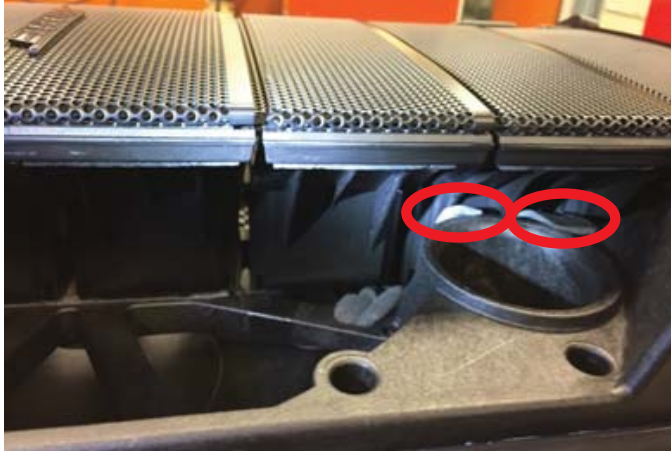
While using a flashlight, use a long stainless steel ruler or similar tool to scrape the foam from the eight locations shown on the woofer baffle.

Take care to remove the foam completely. Do not allow the foam debris to fall behind the array and onto the woofer or elsewhere in the cabinet. The below photo shows the entire piece of foam after it has been removed.
