402™, 502™, 802® II Controllers

180520

Figure correction in service manuals

November 1, 1994

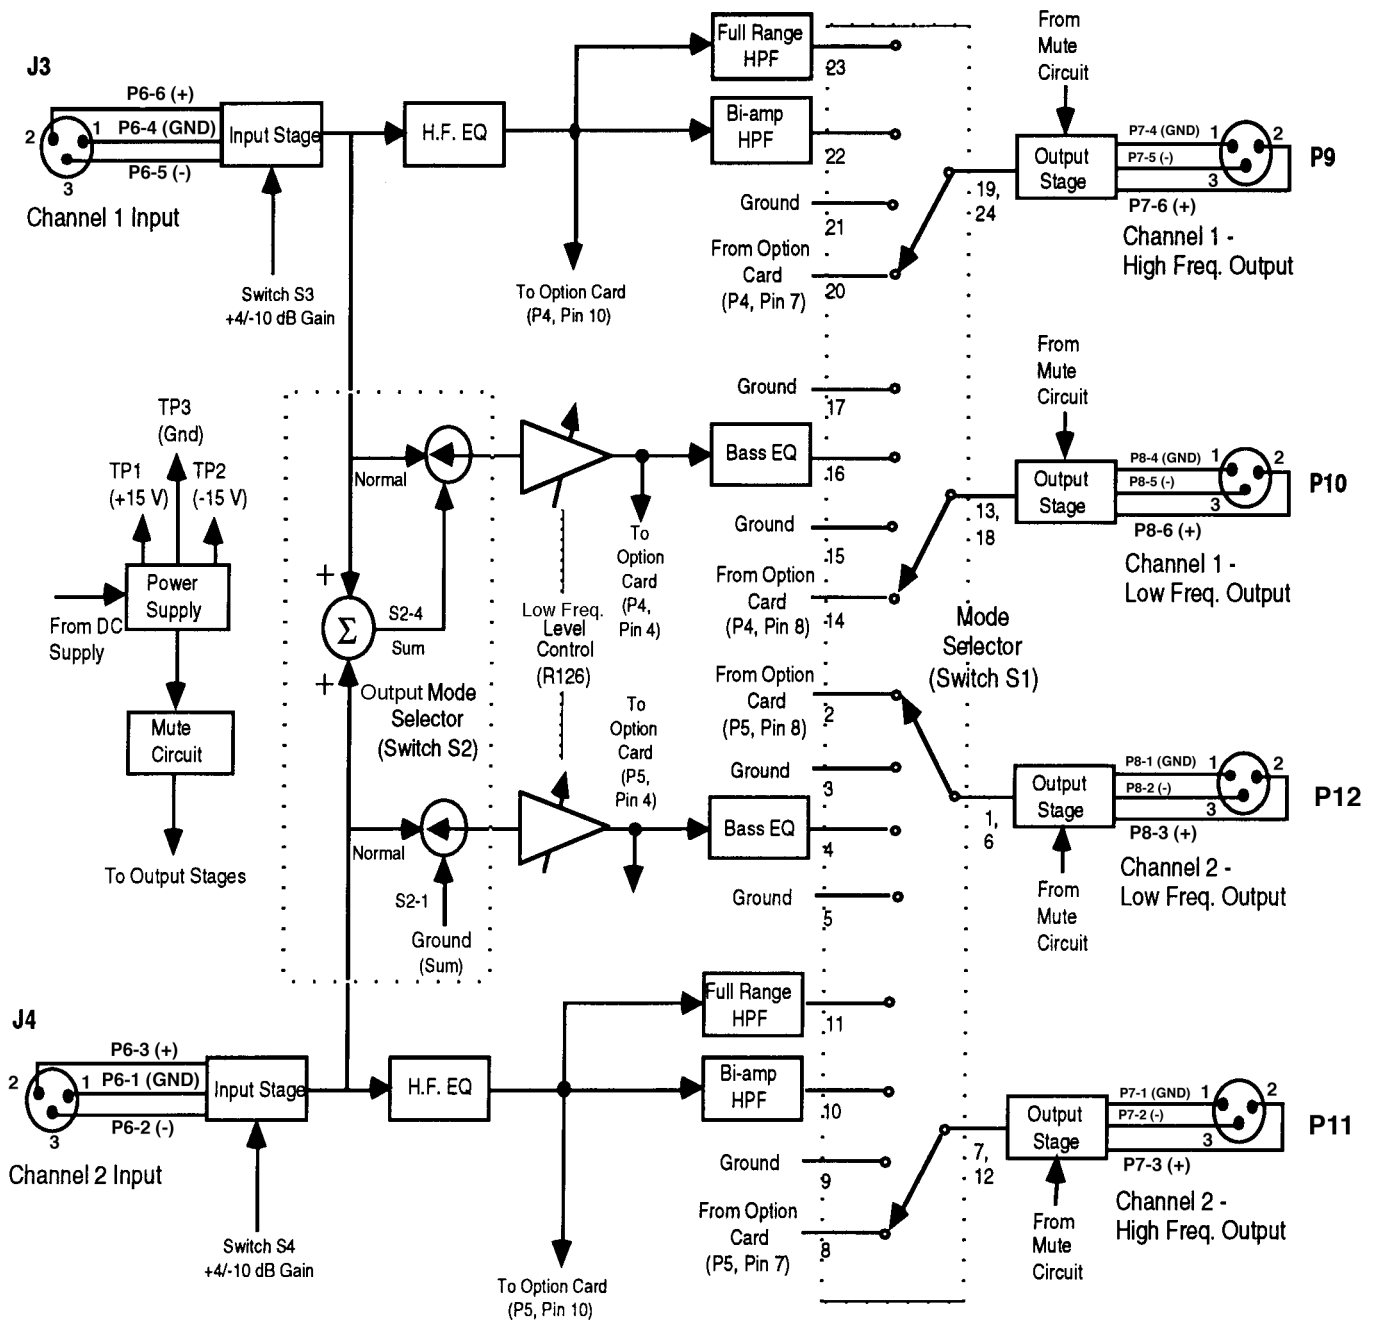
For example, in the original block diagram, for the **Channel 1 High Frequency Output, P7-6 (+)** is shown connected to **pin 3**. In reality, it's connected to **pin 2**. All output connections have been corrected in the new diagram. This agrees with the controller schematics in both manuals.

Additionally, the **Channel 2 High and Low Freq. outputs** had their connections listed backwards. **P11 (Low Freq.)** is now **P12**, and **P12 (High Freq.)** is now **P11**.

Corrected block diagram

A corrected block diagram is attached. This replaces both figures mentioned above.
