SERVICE BULLETIN

Bulletin Part Number: 318882-B3

Product: L1 Compact Portable Line Array System

Subject: Low level audio distortion from line array when playing low frequency content.

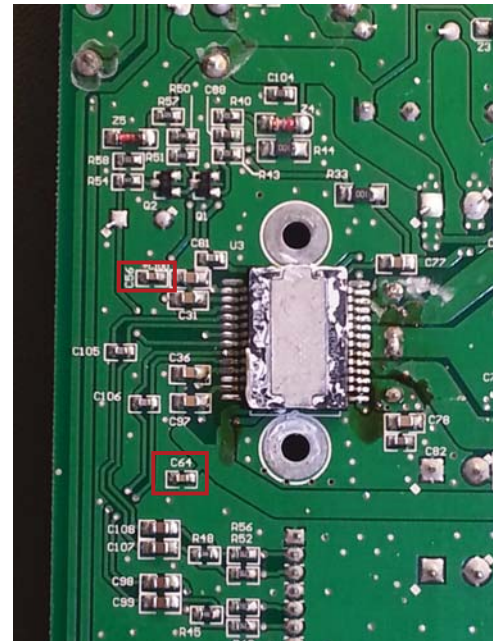
1. Using the disassembly procedures in the L1 Compact service manual, Remove the amplifier/SMPS PCB assembly from the power stand. Remove the aluminum heatsink plate from the bottom of the PCB assembly.
2. Locate SMD capacitors C56 and C64. They are located on the bottom side of the PCB assembly near the amplifier IC, U3. Using a soldering iron, carefully remove C56 and C64 and discard them. Refer to the photo at right for part locations.
3. Place fresh thermal grease onto the amplifier IC, U3, and re-assemble the heatsink to the amplifier/SMPS PCB assembly. Re-install the PCB assembly into the power stand.
4. Perform the test procedures located in the L1 Compact service manual before returning the system to the customer.
